# Access Compliance Report Public Rights-of-Way (Curb Ramps)

| Main Street: NEWPORT_AVE | | Cross Street: LA_COLINA_DR | | Location: | N |
| ADA ID: RPRK211007135435 | Ramp Type: Type 4 - Parallel | Initial Pass/Fail: Fail | Overall Compliance: No | Severity Score: | 0 |

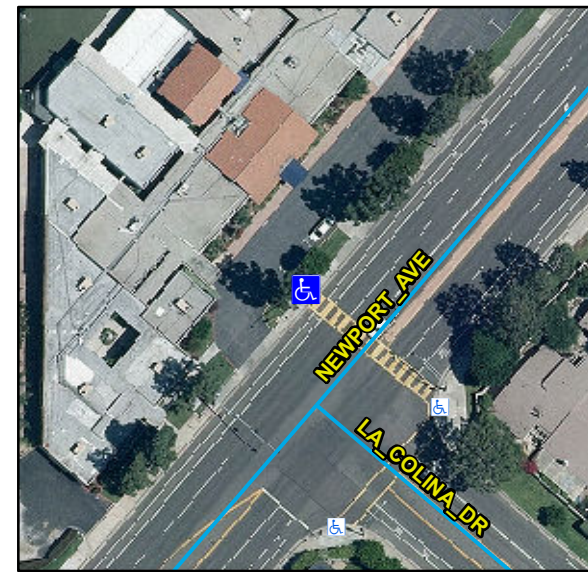
| Compliance | Description | Data | Compliance | Description | Data |
|---|---|---|---|---|---|
| N/A | Gutter Ponding | N/A | No | Curb Slope | 11.4 |

Possible Solutions:

**Remove & Replace Entire Ramp.**

**R304.2.2, STD 1115**

Total Cost: \$ 2000
