# Access Compliance Report Public Rights-of-Way (Curb Ramps)

Main Street: 17TH\_ST Cross Street: HOLT\_AVE Location: S

ADA ID: RPRK211007145234 Ramp Type: Type 4 - Parallel Initial Pass/Fail: Fail Overall Compliance: No Severity Score: 32

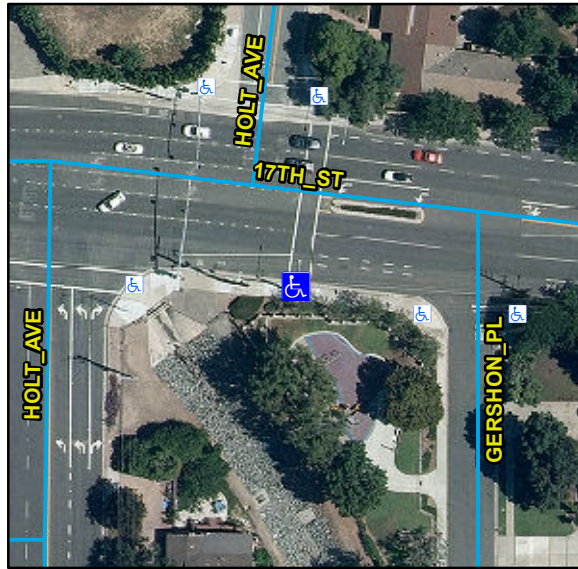
| Compliance | Description | Data | Compliance | Description | Data |
|---|---|---|---|---|---|
| No | Obstructions Present? | Yes | N/A | Utilities Present? | No |
| | Obstruction Types | Traffic Signal Pole | | Utility Types | |

| Compliance | Description | Data | Compliance | Description | Data |
|---|---|---|---|---|---|
| Yes | Ramp Run Slope LT (%) | 4.4 | No | Ramp Run Slope RT (%) | 12.1 |
| No | Ramp Cross Slope LT (%) | 3.4 | Yes | Ramp Cross Slope RT (%) | 0.5 |

Remove & Replace Entire Ramp. Restripe Crosswalk.

R304.5.3, R304.3.2, R302.3, R402.2, STD 1115
