# Access Compliance Report Public Rights-of-Way (Curb Ramps)

Main Street: 17TH\_ST Cross Street: HOLT\_AVE Location: S

ADA ID: RPRK211007145956 Ramp Type: Type 1 - Perpendicular Diagonal Initial Pass/Fail: Fail Overall Compliance: No Severity Score: 30

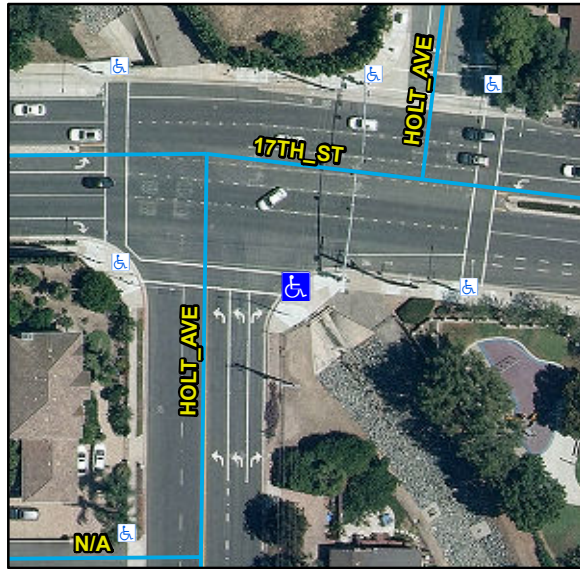
| Compliance | Description | Data | Compliance | Description | Data |
|---|---|---|---|---|---|
| No | Ramp Run Slope (%) | 12.3 | N/A | Flare Slope LT (%) | N/A |

Remove & Replace Curb Ramp With Two New Directional Ramps or Equivalent.

R304.2.2, STD 1115
