# Access Compliance Report Public Rights-of-Way (Curb Ramps)

Main Street: HOLT\_AVE Cross Street: 17TH\_ST Location: SW

ADA ID: RPRK211007150609 Ramp Type: Type 1 - Perpendicular Diagonal Initial Pass/Fail: Fail Overall Compliance: No Severity Score: 16

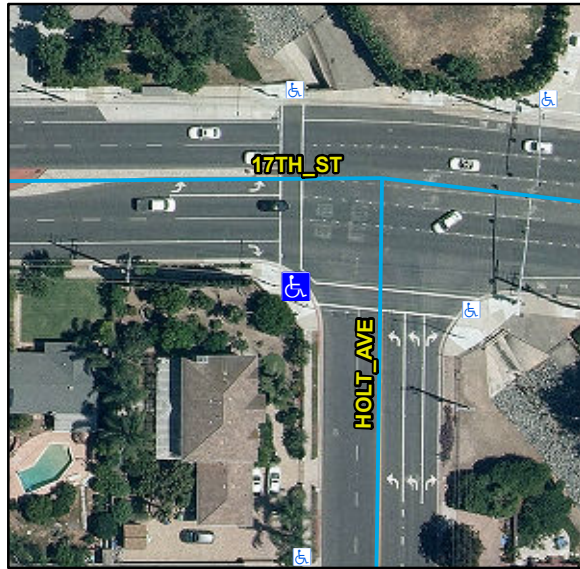
| Compliance | Description | Data | Compliance | Description | Data |
|---|---|---|---|---|---|
| No | Ramp Run Slope (%) | 11.3 | N/A | Flare Slope LT (%) | N/A |
| No | Ramp Cross Slope (%) | 3.6 | N/A | Flare Traversable LT | N/A |
| N/A | Gutter Ponding | N/A | No | Curb Slope | 12.8 |

**Remove & Replace Curb Ramp With Two New Directional Ramps or Equivalent.**

**R304.2.2, R304.5.3, STD 1115**

Total Cost: \$ 6160
