# Access Compliance Report Public Rights-of-Way (Curb Ramps)

Main Street: 17TH\_ST Cross Street: HOLT\_AVE Location: N

ADA ID: RPRK211007150946 Ramp Type: Type 4 - Parallel Initial Pass/Fail: Fail Overall Compliance: No Severity Score: 2

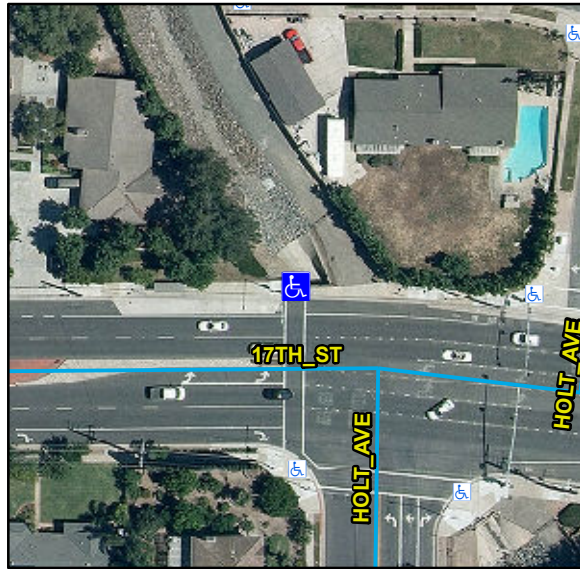
| Compliance | Description | Data | Compliance | Description | Data |
|---|---|---|---|---|---|
| No | Ramp Cross Slope LT (%) | 3.9 | No | Ramp Cross Slope RT (%) | 2.5 |

Remove & Replace Entire Ramp. Restripe Crosswalk.

R304.5.3, STD 1115
