# Access Compliance Report Public Rights-of-Way (Curb Ramps)

Main Street: MAUVE\_DR Cross Street: 17TH\_ST Location: NE

ADA ID: RPRK211007152017 Ramp Type: Type 1 - Perpendicular Diagonal Initial Pass/Fail: Fail Overall Compliance: No Severity Score: 15

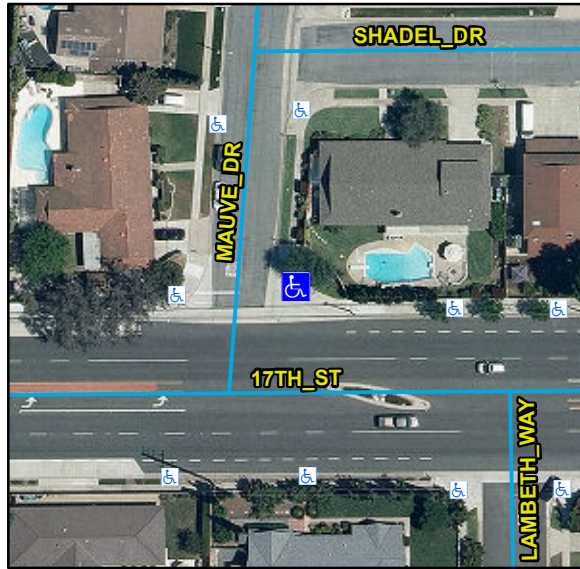
| Compliance | Description | Data | Compliance | Description | Data |
|---|---|---|---|---|---|
| No | Ramp Run Slope (%) | 9.8 | N/A | Flare Slope LT (%) | N/A |

Remove & Replace Curb Ramp With Two New Directional Ramps or Equivalent.

R304.2.2, STD 1115
