# Access Compliance Report Public Rights-of-Way (Curb Ramps)

Main Street: CRAWFORD\_CANYON\_RD Cross Street: CHAPMAN\_AVE Location: SW

ADA ID: RPRK211007170911 Ramp Type: Type 1 - Perpendicular Diagonal Initial Pass/Fail: Fail Overall Compliance: No Severity Score: 30

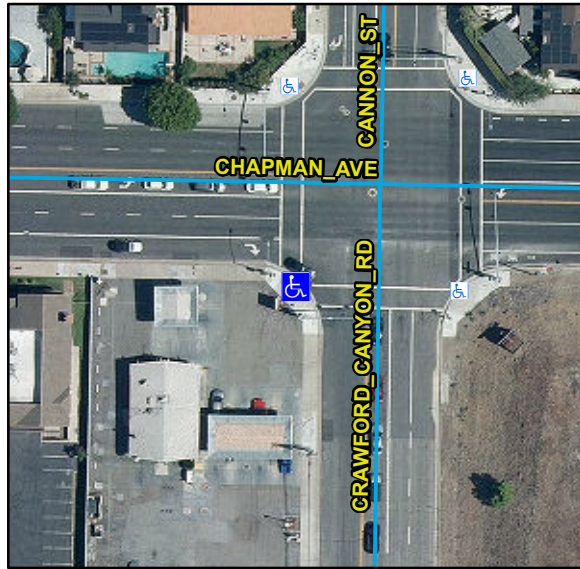
| Compliance | Description | Data | Compliance | Description | Data |
|---|---|---|---|---|---|
| No | Ramp Run Slope (%) | 11.3 | N/A | Flare Slope LT (%) | N/A |
| No | Ramp Cross Slope (%) | 5.8 | N/A | Flare Traversable LT | N/A |

Remove & Replace Curb Ramp With Two New Directional Ramps or Equivalent.

R304.2.2, R304.5.3, STD 1115
