# Access Compliance Report Public Rights-of-Way (Curb Ramps)

Main Street: CHAPMAN\_AVE Cross Street: CRAWFORD\_CANYON\_RD Location: SE

ADA ID: RPRK211007171520 Ramp Type: Type 1 - Perpendicular Diagonal Initial Pass/Fail: Fail Overall Compliance: No Severity Score: 15

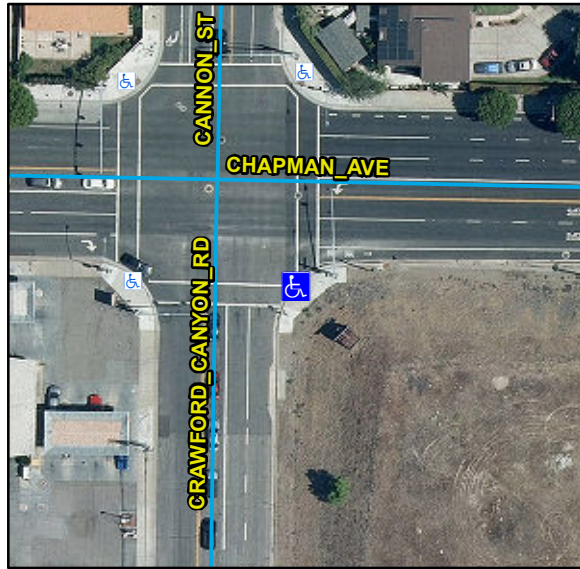
| Compliance | Description | Data | Compliance | Description | Data |
|---|---|---|---|---|---|
| No | Ramp Run Slope (%) | 12 | N/A | Flare Slope LT (%) | N/A |

Remove & Replace Curb Ramp With Two New Directional Ramps or Equivalent.

R304.2.2, R204.3, STD 1115
