# Access Compliance Report Public Rights-of-Way (Curb Ramps)

Main Street: BRAE\_GLEN Cross Street: CRAWFORD\_CANYON\_RD Location: NW

ADA ID: RPRK211007172336 Ramp Type: Type 1 - Perpendicular Diagonal Initial Pass/Fail: Pass Overall Compliance: No Severity Score: 28

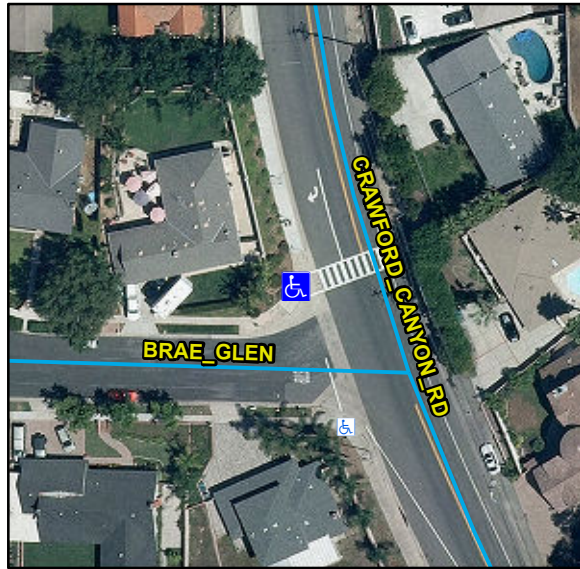
| Compliance | Description | Data | Compliance | Description | Data |
|---|---|---|---|---|---|
| Yes | Ramp Run Slope (%) | 8.3 | No | Flare Slope LT (%) | 11.4 |
| No | Landing Width (in) | N/A | Yes | Flare Slope RT (%) | 9.8 |
| No | Landing Cross Slope (%) | N/A | No | DWS Provided | No |
| No | Gutter Run Slope (%) | 6 | | Road Cross Slope (%) | 0.1 |
| No | Gutter Cross Slope (%) | 4.2 | | | |

Remove & Replace Curb Ramp With Two New Directional Ramps or Equivalent. Restripe Crosswalk. Remove & Replace Gutter.
