# Access Compliance Report Public Rights-of-Way (Curb Ramps)

Main Street: CRAWFORD\_CANYON\_RD Cross Street: BRAE\_GLEN Location: SW

ADA ID: RPRK211007172721 Ramp Type: Type 1 - Perpendicular Diagonal Initial Pass/Fail: Fail Overall Compliance: No Severity Score: 15

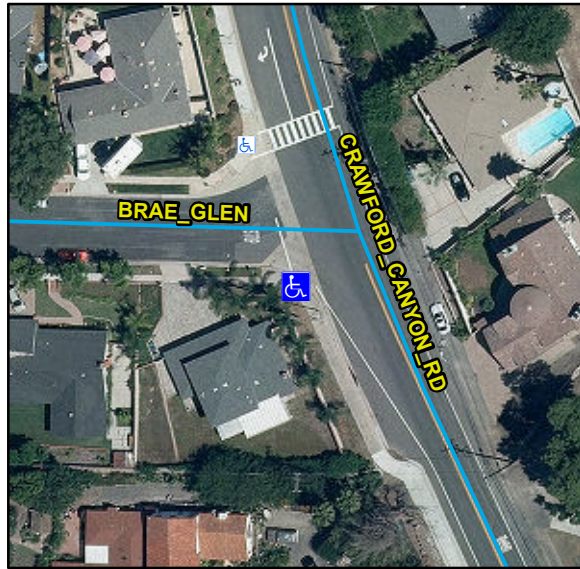
| Compliance | Description | Data | Compliance | Description | Data |
|---|---|---|---|---|---|
| No | Ramp Run Slope (%) | 10.4 | N/A | Flare Slope LT (%) | N/A |

Remove & Replace Curb Ramp With Two New Directional Ramps or Equivalent.

R304.2.2, STD 1115
