# Access Compliance Report Public Rights-of-Way (Curb Ramps)

Main Street: CRAWFORD\_CANYON\_RD Cross Street: STOLLER\_LN Location: SW

ADA ID: RPRK211007172919 Ramp Type: Type 1 - Perpendicular Diagonal Initial Pass/Fail: Fail Overall Compliance: No Severity Score: 30

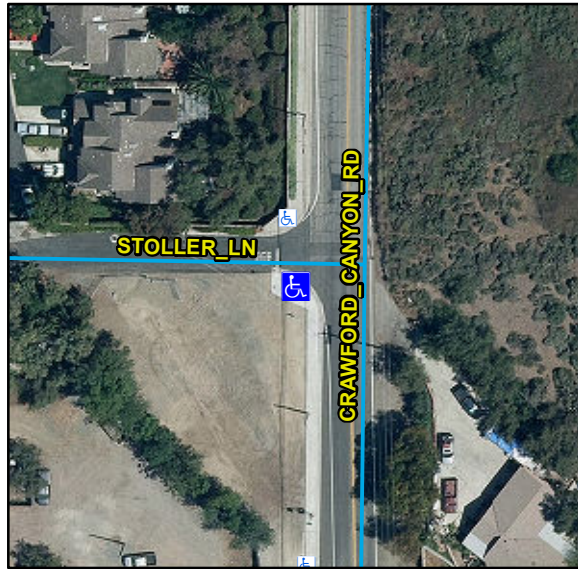
| Compliance | Description | Data | Compliance | Description | Data |
|---|---|---|---|---|---|
| No | Ramp Run Slope (%) | 12.1 | N/A | Flare Slope LT (%) | N/A |

Remove & Replace Curb Ramp With Two New Directional Ramps or Equivalent.
