# Access Compliance Report Public Rights-of-Way (Curb Ramps)

Main Street: STOLLER\_LN Cross Street: CRAWFORD\_CANYON\_RD Location: NW

ADA ID: RPRK211007173321 Ramp Type: Type 1 - Perpendicular Diagonal Initial Pass/Fail: Fail Overall Compliance: No Severity Score: 60

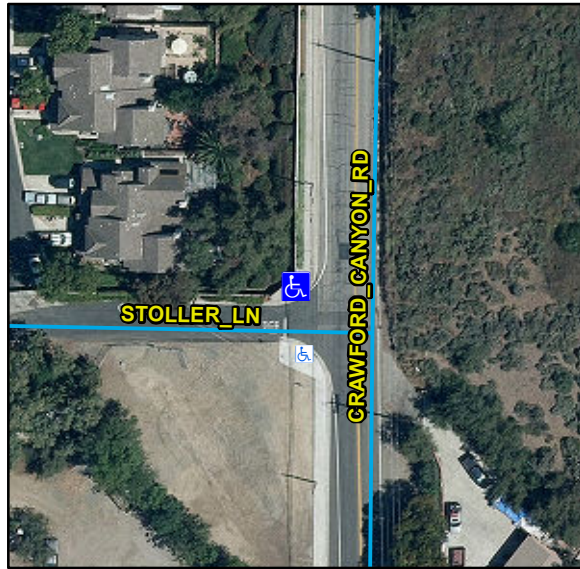
| Compliance | Description | Data | Compliance | Description | Data |
|---|---|---|---|---|---|
| No | Ramp Run Slope (%) | 14 | N/A | Flare Slope LT (%) | N/A |
| No | Ramp Cross Slope (%) | 14.7 | N/A | Flare Traversable LT | N/A |
| No | Gutter Lip Height (in) | 0.25 | | Road Run Slope (%) | 7.1 |

Remove & Replace Curb Ramp With Two New Directional Ramps or Equivalent.
