# Access Compliance Report Public Rights-of-Way (Curb Ramps)

Main Street: SAYLOR\_TE Cross Street: CRAWFORD\_CANYON\_RD Location: NW

ADA ID: RPRK211007174536 Ramp Type: Type 7 - Directional 2 Initial Pass/Fail: Fail Overall Compliance: No Severity Score: 30

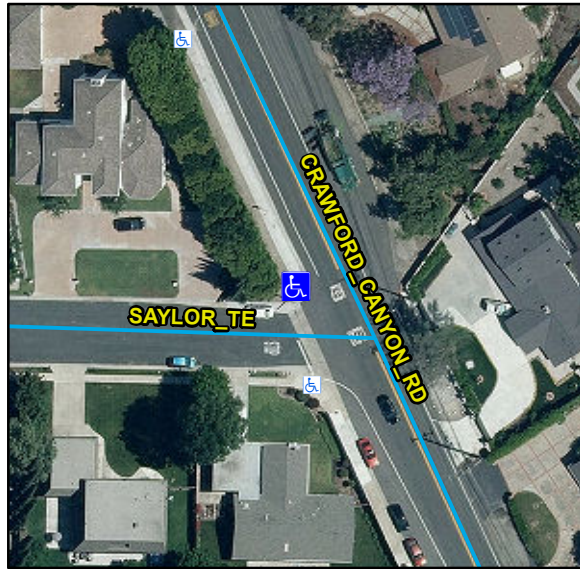
| Compliance | Description | Data | Compliance | Description | Data |
|---|---|---|---|---|---|
| No | Ramp Run Slope (%) | 12.1 | N/A | Flare Slope LT (%) | N/A |

Remove & Replace Entire Ramp.

R204.3, R304.2.2, STD 1115
