# Access Compliance Report Public Rights-of-Way (Curb Ramps)

Main Street: CRAWFORD\_CANYON\_RD Cross Street: SAYLOR\_TE Location: SW

ADA ID: RPRK211007174740 Ramp Type: Type 1 - Perpendicular Diagonal Initial Pass/Fail: Fail Overall Compliance: No Severity Score: 15

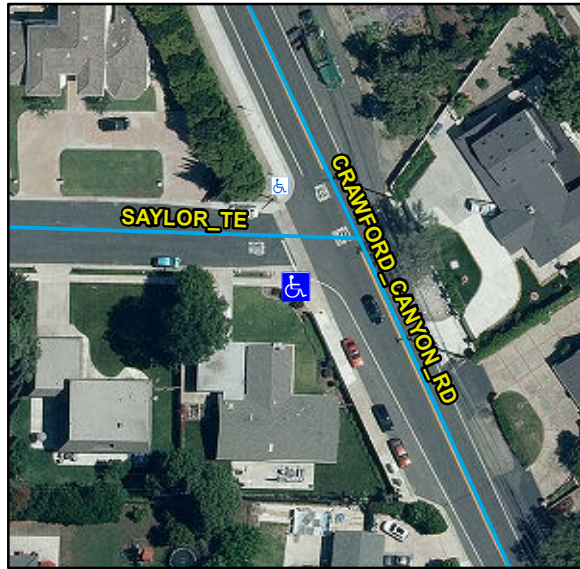
| Compliance | Description | Data | Compliance | Description | Data |
|---|---|---|---|---|---|
| No | Ramp Run Slope (%) | 11.8 | N/A | Flare Slope LT (%) | N/A |

Remove & Replace Curb Ramp With Two New Directional Ramps or Equivalent.
