# Access Compliance Report Public Rights-of-Way (Curb Ramps)

Main Street: BARRETT\_LN Cross Street: CRAWFORD\_CANYON\_RD Location: W

ADA ID: RPRK211007175241 Ramp Type: Type 4 - Parallel Initial Pass/Fail: Fail Overall Compliance: No Severity Score: 16

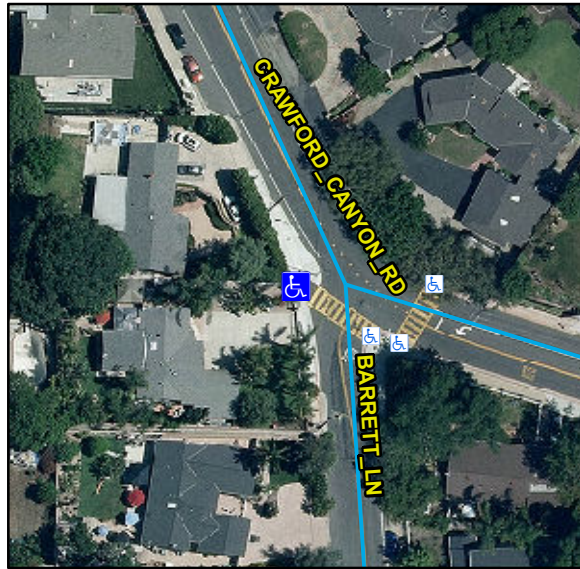
| Compliance | Description | Data | Compliance | Description | Data |
|---|---|---|---|---|---|
| No | Obstructions Present? | Yes | N/A | Utilities Present? | No |
| | Obstruction Types | Pushbutton Post | | Utility Types | |

| Compliance | Description | Data | Compliance | Description | Data |
|---|---|---|---|---|---|
| Yes | Ramp Run Slope LT (%) | 0.1 | No | Ramp Run Slope RT (%) | 10.7 |

Remove & Replace Entire Ramp.

R304.3.2, R302.3, R402.2, STD 1115
