# Access Compliance Report Public Rights-of-Way (Curb Ramps)

Main Street: CRAWFORD\_CANYON\_RD Cross Street: BARRETT\_LN Location: S

ADA ID: RPRK211007175747 Ramp Type: Type 1 - Perpendicular Initial Pass/Fail: Fail Overall Compliance: No Severity Score: 2

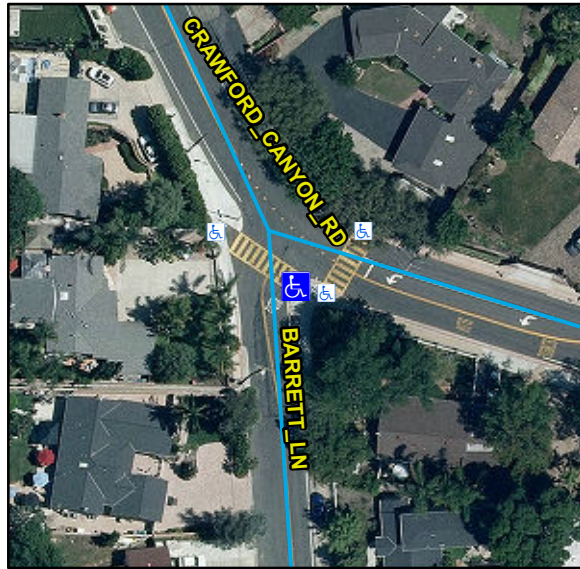
| Compliance | Description | Data | Compliance | Description | Data |
|---|---|---|---|---|---|
| No | Ramp Cross Slope (%) | 3.8 | N/A | Flare Traversable LT | N/A |

Remove & Replace Entire Ramp.

R304.2.2, R304.5.3, STD 1115

Total Cost: \$ 3080
