# Access Compliance Report Public Rights-of-Way (Curb Ramps)

| Main Street: CRAWFORD_CANYON_RD | | Cross Street: BARRETT_LN | | Location: | SE |
| ADA ID: RPRK211007175924 | Ramp Type:Type 1 - Perpendicular | Initial Pass/Fail: Pass | Overall Compliance: No | Severity Score: | 12 |

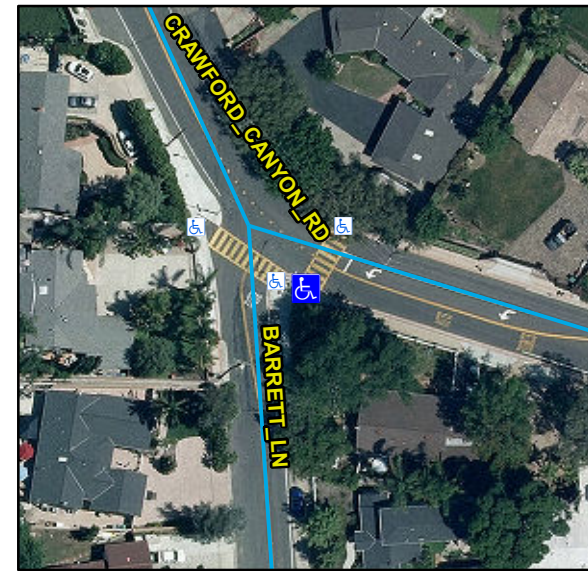
| Compliance | Description | Data | Compliance | Description | Data |
|---|---|---|---|---|---|
| No | Landing Run Slope (%) | 3.2 | N/A | Flare Traversable RT | No |
| No | Gutter Run Slope (%) | 9 | | Road Cross Slope (%) | N/A |

**Remove & Replace Entire Ramp. Remove & Replace Gutter.**

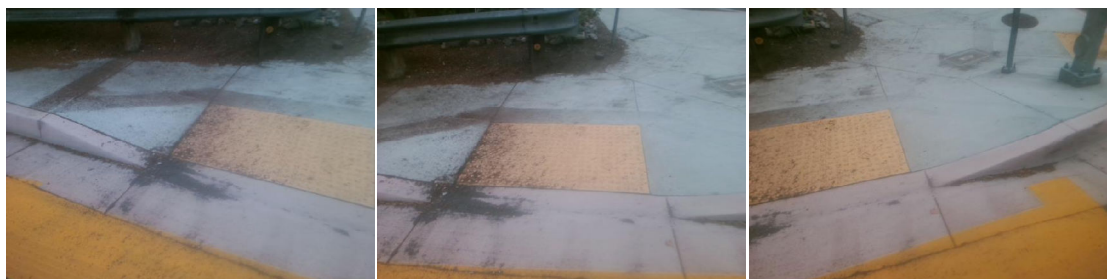
| Compliance | Description | Data | Compliance | Description | Data |
|---|---|---|---|---|---|
| N/A | Ramp Length (in) | 48 | N/A | Flare Type LT | |
| Yes | Ramp Run Slope (%) | 7.5 | N/A | Flare Slope LT (%) | 16.1 |
