# Access Compliance Report Public Rights-of-Way (Curb Ramps)

Main Street: CRAWFORD\_CANYON\_RD Cross Street: BARRETT\_LN Location: NE

ADA ID: RPRK211007180451 Ramp Type: Type 4 - Parallel Initial Pass/Fail: Fail Overall Compliance: No Severity Score: 0

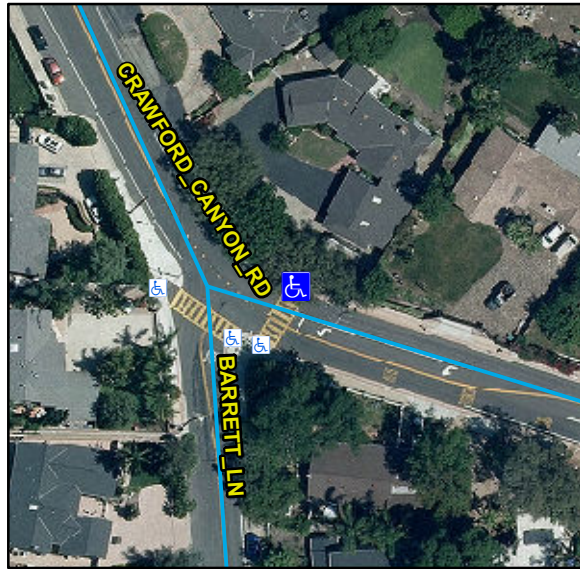
| Compliance | Description | Data | Compliance | Description | Data |
|---|---|---|---|---|---|
| N/A | Gutter Ponding | N/A | No | Curb Slope | 11.8 |

Remove & Replace Entire Ramp.

R304.2.2, STD 1115
