# Access Compliance Report Public Rights-of-Way (Curb Ramps)

Main Street: COUNTY\_LN Cross Street: COUNTRY\_HAVEN\_LN Location: SW

ADA ID: RPRK211007181656 Ramp Type: Type 1 - Perpendicular Diagonal Initial Pass/Fail: Fail Overall Compliance: No Severity Score: 30

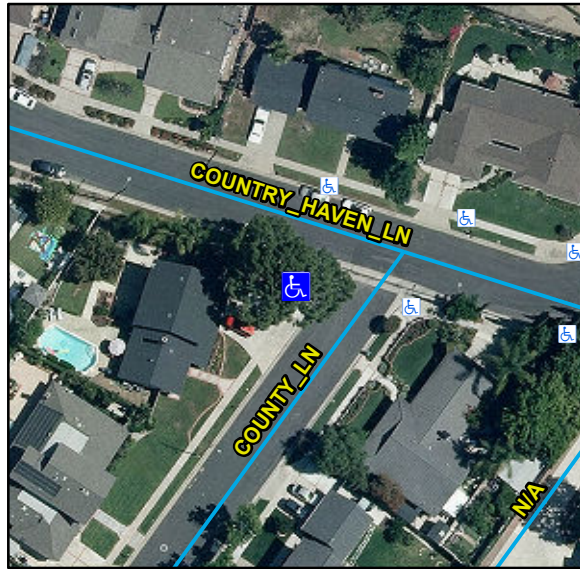
| Compliance | Description | Data | Compliance | Description | Data |
|---|---|---|---|---|---|
| No | Ramp Run Slope (%) | 12.4 | N/A | Flare Slope LT (%) | N/A |
| No | Gutter Lip Height (in) | 0.5 | | Road Run Slope (%) | 2.1 |

Remove & Replace Curb Ramp With Two New Directional Ramps or Equivalent.

R304.2.2, R302.7.2, STD 1115
