# Access Compliance Report Public Rights-of-Way (Curb Ramps)

Main Street: COUNTRY\_HAVEN\_LN Cross Street: COUNTY\_LN Location: SE

ADA ID: RPRK211007181847 Ramp Type: Type 1 - Perpendicular Diagonal Initial Pass/Fail: Fail Overall Compliance: No Severity Score: 32

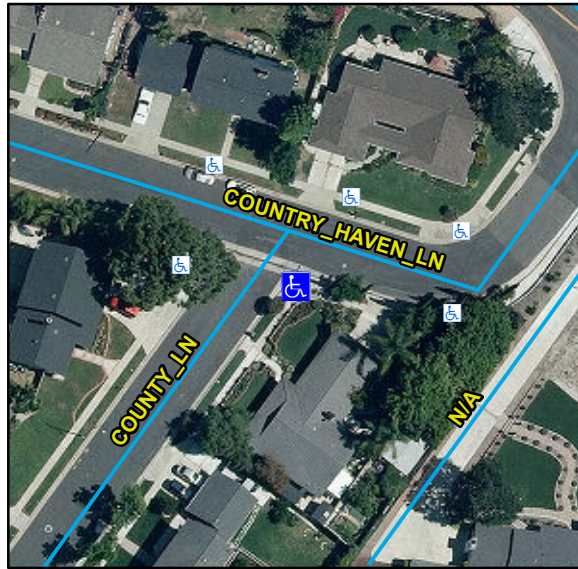
| Compliance | Description | Data | Compliance | Description | Data |
|---|---|---|---|---|---|
| No | Ramp Run Slope (%) | 13.6 | N/A | Flare Slope LT (%) | N/A |
| No | Ramp Cross Slope (%) | 3.1 | N/A | Flare Traversable LT | N/A |
| No | Gutter Lip Height (in) | 0.25 | | Road Run Slope (%) | 1.5 |

Remove & Replace Curb Ramp With Two New Directional Ramps or Equivalent.

R304.2.2, R304.5.3, R302.7.2, STD 1115
