# Access Compliance Report Public Rights-of-Way (Curb Ramps)

Main Street: 17TH\_ST Cross Street: HEWES\_AVE Location: NW

ADA ID: RPRK211008122259 Ramp Type: Type 1 - Perpendicular Diagonal Initial Pass/Fail: Pass Overall Compliance: No Severity Score: 2

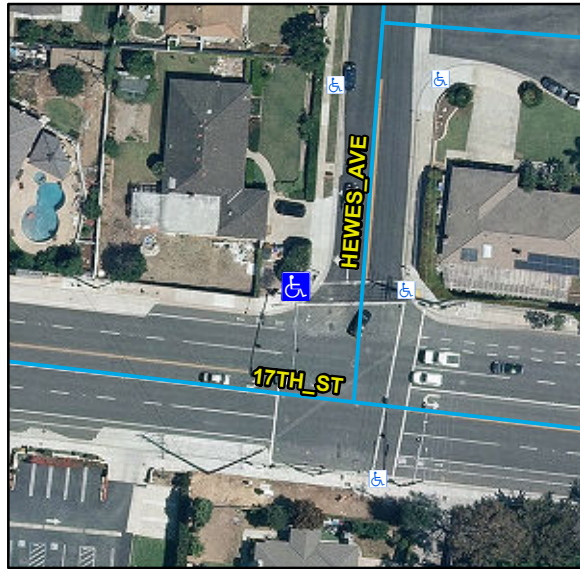
| Compliance | Description | Data | Compliance | Description | Data |
|---|---|---|---|---|---|
| No | Landing Run Slope (%) | 3.2 | N/A | Flare Traversable RT | Yes |
| Yes | Gutter Ponding | No | No | Curb Slope | 13.3 |
| No | Gutter Cross Slope (%) | 4.1 | | | |

Remove & Replace Curb Ramp With Two New Directional Ramps or Equivalent. Remove & Replace Gutter.

R304.2.2, R304.2.2-Perp, R304.3.2-Para, R304.5.3, STD 1115

Total Cost: \$ 6412
