# Access Compliance Report Public Rights-of-Way (Curb Ramps)

Main Street: HEWES\_AVE Cross Street: 17TH\_ST Location: NE

ADA ID: RPRK211008123026 Ramp Type: Type 1 - Perpendicular Diagonal Initial Pass/Fail: Fail Overall Compliance: No Severity Score: 30

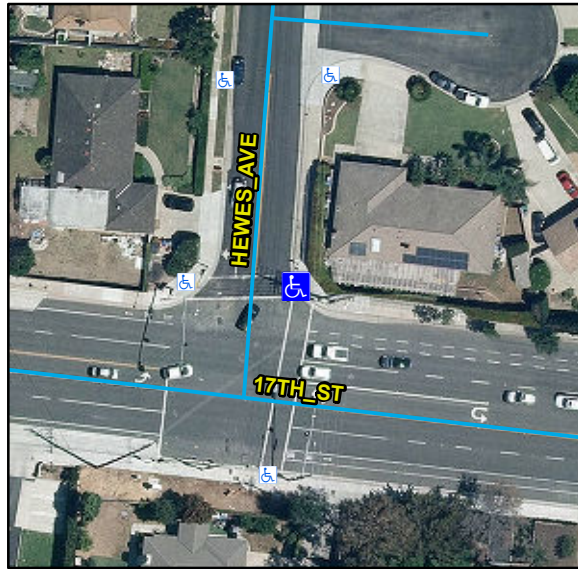
| Compliance | Description | Data | Compliance | Description | Data |
|---|---|---|---|---|---|
| No | Ramp Cross Slope (%) | 11 | N/A | Flare Traversable LT | N/A |
| N/A | Gutter Ponding | N/A | No | Curb Slope | 8.2 |

Remove & Replace Curb Ramp With Two New Directional Ramps or Equivalent.

R304.2.2, R304.5.3, STD 1115
