# Access Compliance Report Public Rights-of-Way (Curb Ramps)

Main Street: 17TH\_ST Cross Street: HEWES\_AVE Location: S

ADA ID: RPRK211008123423 Ramp Type: Type 1 - Perpendicular Initial Pass/Fail: Fail Overall Compliance: No Severity Score: 15

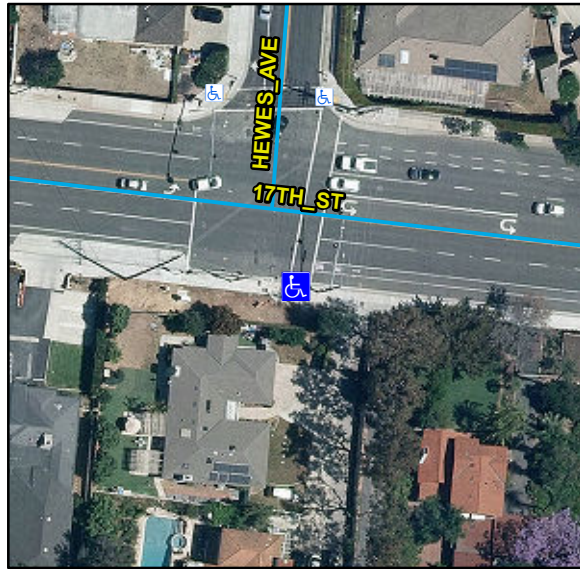
| Compliance | Description | Data | Compliance | Description | Data |
|---|---|---|---|---|---|
| No | Ramp Run Slope (%) | 11 | N/A | Flare Slope LT (%) | N/A |
| N/A | Gutter Ponding | N/A | No | Curb Slope | 16 |

Remove & Replace Entire Ramp.

R304.2.2, STD 1115
