# Access Compliance Report Public Rights-of-Way (Curb Ramps)

Main Street: 17TH\_ST Cross Street: WINDSOR\_PL Location: SE

ADA ID: RPRK211008123927 Ramp Type: Type 6 - Directional 1 Initial Pass/Fail: Fail Overall Compliance: No Severity Score: 15

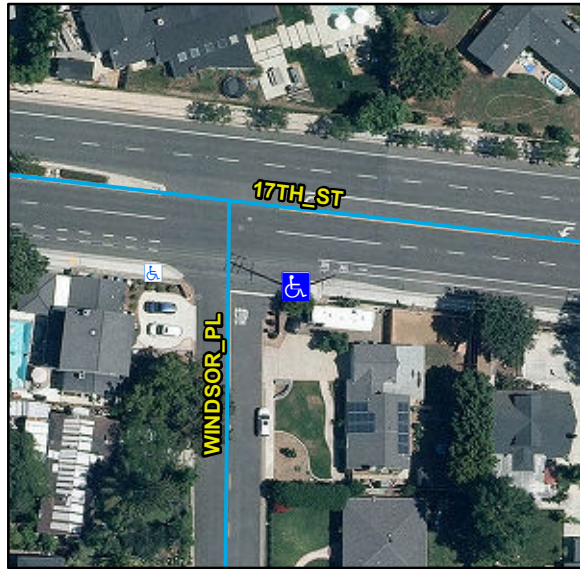
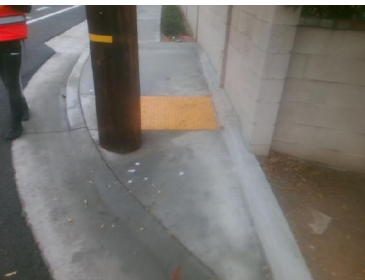
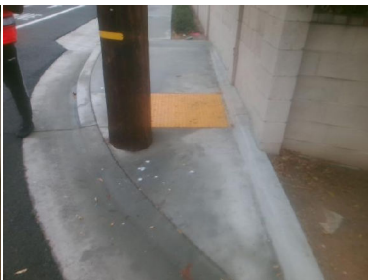
| Compliance | Description | Data | Compliance | Description | Data |
|---|---|---|---|---|---|
| No | Obstructions Present? | Yes | N/A | Utilities Present? | No |
| | Obstruction Types | Power Pole | | Utility Types | |

| Compliance | Description | Data | Compliance | Description | Data |
|---|---|---|---|---|---|
| No | Ramp Run Slope (%) | 11.2 | N/A | Flare Slope LT (%) | N/A |

Remove & Replace Curb Ramp With Two New Directional Ramps or Equivalent.

R304.2.2, R302.3, R402.2, STD 1115
