# Access Compliance Report Public Rights-of-Way (Curb Ramps)

Main Street: WINDSOR\_PL Cross Street: 17TH\_ST Location: SW

ADA ID: RPRK211008124158 Ramp Type: Type 7 - Directional 2 Initial Pass/Fail: Fail Overall Compliance: No Severity Score: 16

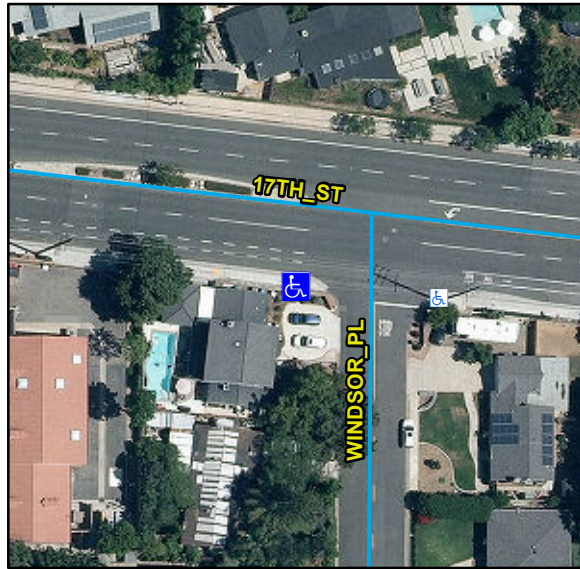
| Compliance | Description | Data | Compliance | Description | Data |
|---|---|---|---|---|---|
| No | Ramp Run Slope (%) | 10.7 | N/A | Flare Slope LT (%) | N/A |
| No | Ramp Cross Slope (%) | 2.2 | N/A | Flare Traversable LT | N/A |

Remove & Replace Entire Ramp.

R304.2.2, R304.5.3, STD 1115
