# Access Compliance Report Public Rights-of-Way (Curb Ramps)

Main Street: N/A Cross Street: 17TH\_ST Location: NW

ADA ID: RPRK211008125037 Ramp Type: Type 7 - Directional 2 Initial Pass/Fail: Fail Overall Compliance: No Severity Score: 32

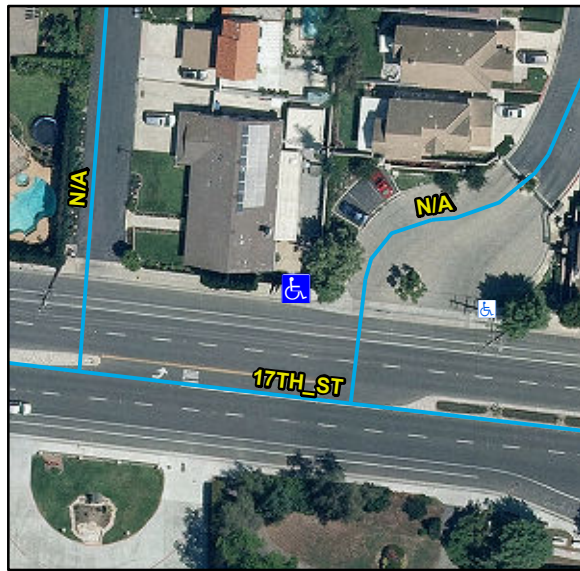
| Compliance | Description | Data | Compliance | Description | Data |
|---|---|---|---|---|---|
| No | Ramp Run Slope (%) | 12.6 | N/A | Flare Slope LT (%) | N/A |

Remove & Replace Entire Ramp.
