# Access Compliance Report Public Rights-of-Way (Curb Ramps)

Main Street: N/A Cross Street: 17TH\_ST Location: N

ADA ID: RPRK211008125217 Ramp Type: Type 7 - Directional 2 Initial Pass/Fail: Fail Overall Compliance: No Severity Score: 15

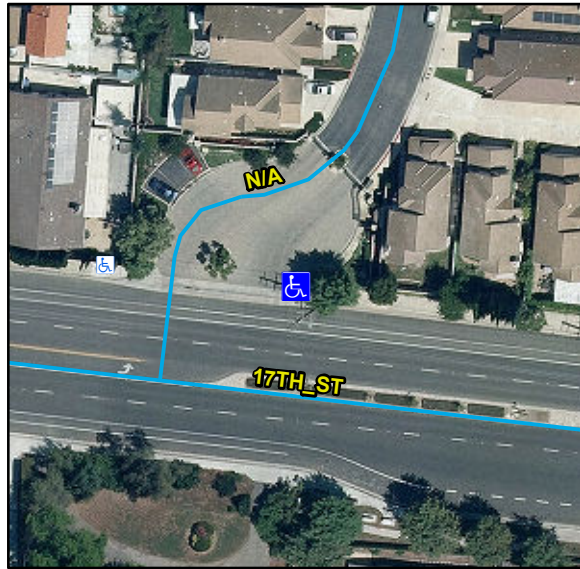
| Compliance | Description | Data | Compliance | Description | Data |
|---|---|---|---|---|---|
| No | Ramp Run Slope (%) | 10 | N/A | Flare Slope LT (%) | N/A |

Remove & Replace Entire Ramp.

R304.2.2, STD 1115
