# Access Compliance Report Public Rights-of-Way (Curb Ramps)

Main Street: GIMBERT\_LN Cross Street: 17TH\_ST Location: NE

ADA ID: RPRK211008125706 Ramp Type: Type 1 - Perpendicular Diagonal Initial Pass/Fail: Fail Overall Compliance: No Severity Score: 45

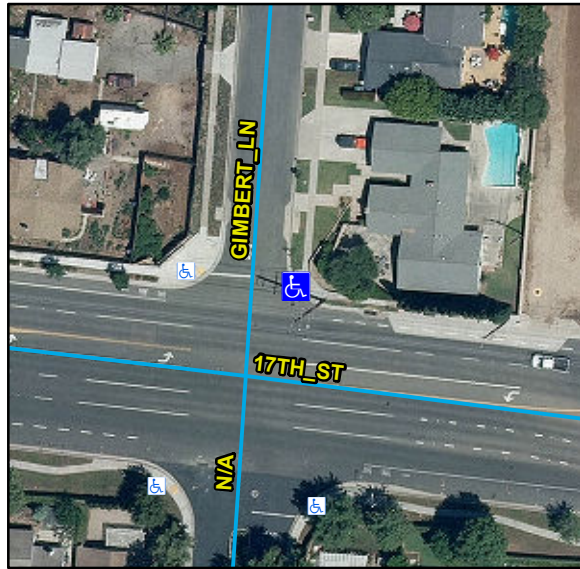
| Compliance | Description | Data | Compliance | Description | Data |
|---|---|---|---|---|---|
| No | Ramp Run Slope (%) | 9.3 | N/A | Flare Slope LT (%) | N/A |
| No | Ramp Cross Slope (%) | 13.2 | N/A | Flare Traversable LT | N/A |

Remove & Replace Curb Ramp With Two New Directional Ramps or Equivalent.
