# Access Compliance Report Public Rights-of-Way (Curb Ramps)

Main Street: NEWPORT\_AVE Cross Street: CHARWOOD\_LN Location: N

ADA ID: RPRK211008131442 Ramp Type: Type 1 - Perpendicular Diagonal Initial Pass/Fail: Fail Overall Compliance: No Severity Score: 15

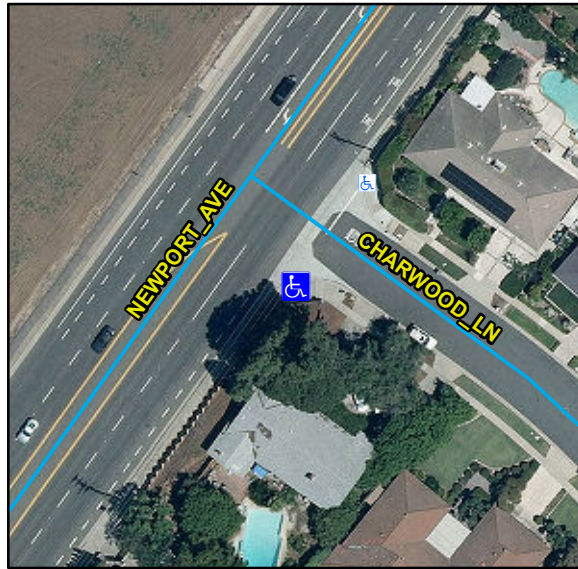
| Compliance | Description | Data | Compliance | Description | Data |
|---|---|---|---|---|---|
| N/A | Ramp Length (in) | 125 | N/A | Flare Type LT | |
| Yes | Ramp Width (in) | 48 | | | N/A |
| No | Ramp Run Slope (%) | 10.2 | N/A | Flare Slope LT (%) | N/A |
| Yes | Ramp Cross Slope (%) | 1.2 | N/A | Flare Traversable LT | N/A |

**Remove & Replace Curb Ramp With Two New Directional Ramps or Equivalent.**

**R304.2.2, STD 1115**

Total Cost: \$ 6160
