# Access Compliance Report Public Rights-of-Way (Curb Ramps)

Main Street: NEWPORT\_AVE Cross Street: CHARWOOD\_LN Location: E

ADA ID: RPRK211008131629 Ramp Type: Type 1 - Perpendicular Diagonal Initial Pass/Fail: Fail Overall Compliance: No Severity Score: 2

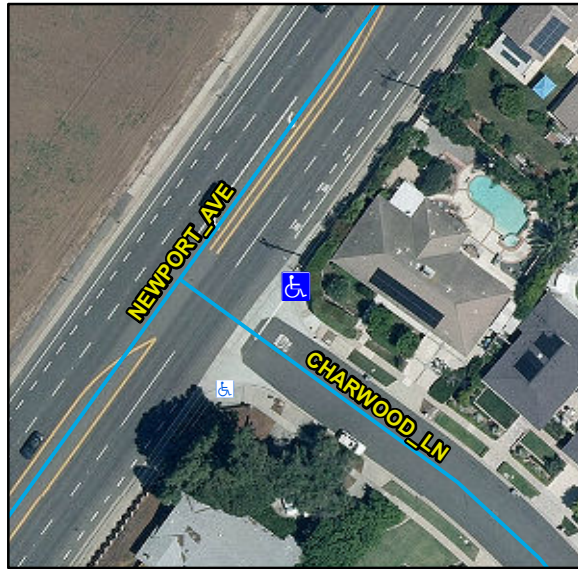
R304.2.2, R304.5.3, STD 1115

| Compliance | Description | Data | Compliance | Description | Data |
|---|---|---|---|---|---|
| No | Ramp Cross Slope (%) | 3.4 | N/A | Flare Traversable LT | N/A |

**Remove & Replace Curb Ramp With Two New Directional Ramps or Equivalent.**
