# Access Compliance Report Public Rights-of-Way (Curb Ramps)

| Main Street: NEWPORT_AVE | Cross Street: CASTLEGATE_LN | Location: W |

| ADA ID: RPRK211008132300 | Ramp Type: Type 1 - Perpendicular Diagonal | Initial Pass/Fail: Fail | Overall Compliance: No | Severity Score: 2 |

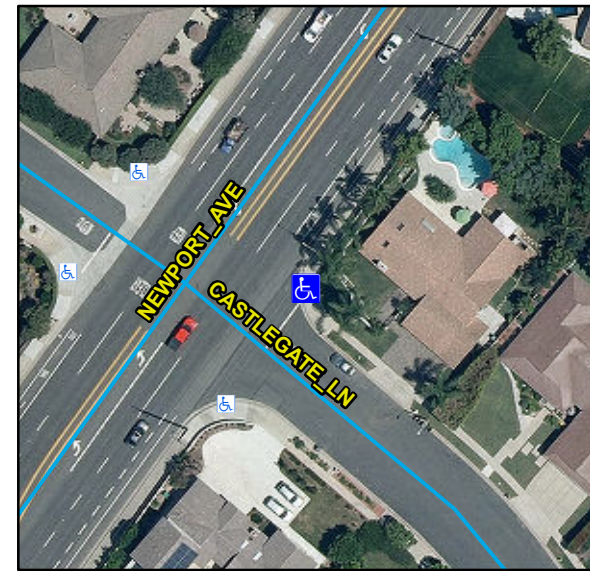
| Compliance | Description | Data | Compliance | Description | Data |
|---|---|---|---|---|---|
| No | Ramp Cross Slope (%) | 4.9 | N/A | Flare Traversable LT | N/A |
| N/A | Gutter Ponding | N/A | No | Curb Slope | 8 |

**Remove & Replace Curb Ramp With Two New Directional Ramps or Equivalent.**
