# Access Compliance Report Public Rights-of-Way (Curb Ramps)

Main Street: CASTLEGATE\_LN Cross Street: NEWPORT\_AVE Location: N

ADA ID: RPRK211008132449 Ramp Type: Type 1 - Perpendicular Diagonal Initial Pass/Fail: Fail Overall Compliance: No Severity Score: 15

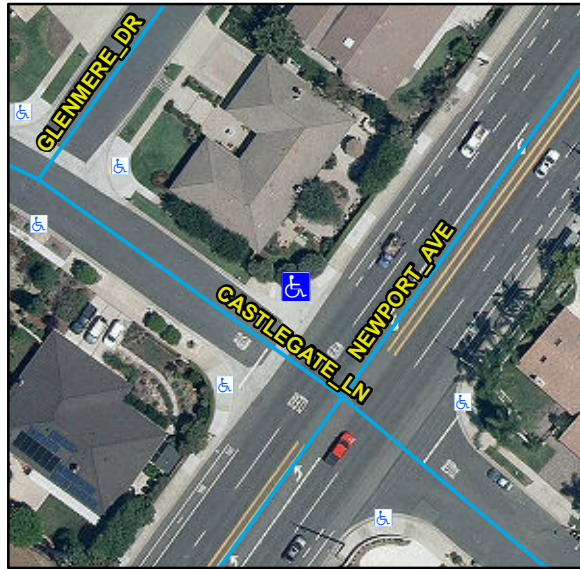
| Compliance | Description | Data | Compliance | Description | Data |
|---|---|---|---|---|---|
| No | Ramp Run Slope (%) | 11 | N/A | Flare Slope LT (%) | N/A |

Remove & Replace Curb Ramp With Two New Directional Ramps or Equivalent.

R304.2.2, STD 1115
