# Access Compliance Report Public Rights-of-Way (Curb Ramps)

Main Street: NEWPORT\_AVE Cross Street: CASTLEGATE\_LN Location: W

ADA ID: RPRK211008132711 Ramp Type: Type 1 - Perpendicular Diagonal Initial Pass/Fail: Fail Overall Compliance: No Severity Score: 16

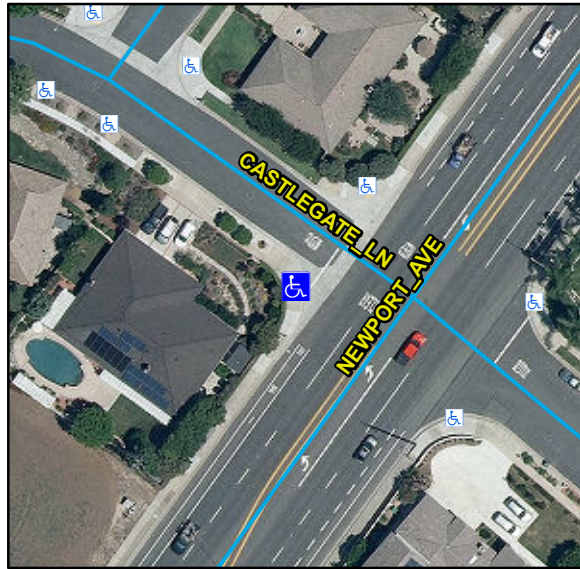
| Compliance | Description | Data | Compliance | Description | Data |
|---|---|---|---|---|---|
| No | Ramp Run Slope (%) | 11 | N/A | Flare Slope LT (%) | N/A |
| No | Ramp Cross Slope (%) | 3.1 | N/A | Flare Traversable LT | N/A |

**Remove & Replace Curb Ramp With Two New Directional Ramps or Equivalent.**

**R304.2.2, R304.5.3, STD 1115**
