# Access Compliance Report Public Rights-of-Way (Curb Ramps)

Main Street: CASTLEGATE\_LN Cross Street: GLENMERE\_DR Location: N

ADA ID: RPRK211008133308 Ramp Type: Type 1 - Perpendicular Diagonal Initial Pass/Fail: Fail Overall Compliance: No Severity Score: 16

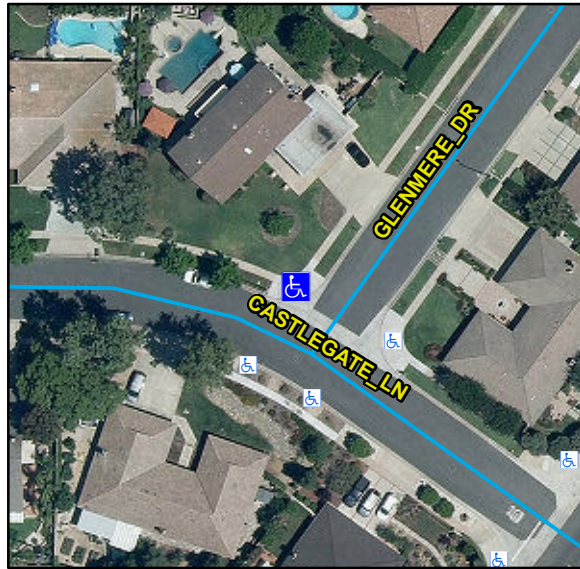
| Compliance | Description | Data | Compliance | Description | Data |
|---|---|---|---|---|---|
| No | Ramp Run Slope (%) | 9.5 | N/A | Flare Slope LT (%) | N/A |
| No | Ramp Cross Slope (%) | 4.7 | N/A | Flare Traversable LT | N/A |

Remove & Replace Curb Ramp With Two New Directional Ramps or Equivalent.

R304.2.2, R304.5.3, STD 1115
