# Access Compliance Report Public Rights-of-Way (Curb Ramps)

| Main Street: GLENMERE_DR | | Cross Street: CHADBOURNE_LN | | Location: | W |
| ADA ID: RPRK211008133620 | Ramp Type:Type 1 - Perpendicular Diagonal Initial Pass/Fail: Fail | | Overall Compliance: No | Severity Score: | 16 |

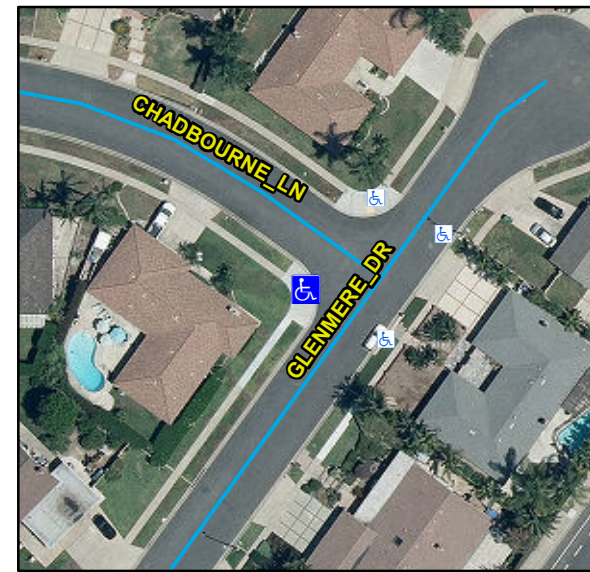
| Compliance | Description | Data | Compliance | Description | Data |
|---|---|---|---|---|---|
| No | Ramp Run Slope (%) | 11.5 | N/A | Flare Slope LT (%) | N/A |

**Remove & Replace Curb Ramp With Two New Directional Ramps or Equivalent.**

**R304.2.2, STD 1115**
