# Access Compliance Report Public Rights-of-Way (Curb Ramps)

Main Street: CHADBOURNE\_LN Cross Street: GLENMERE\_DR Location: NE

ADA ID: RPRK211008133806 Ramp Type: Type 1 - Perpendicular Diagonal Initial Pass/Fail: Fail Overall Compliance: No Severity Score: 45

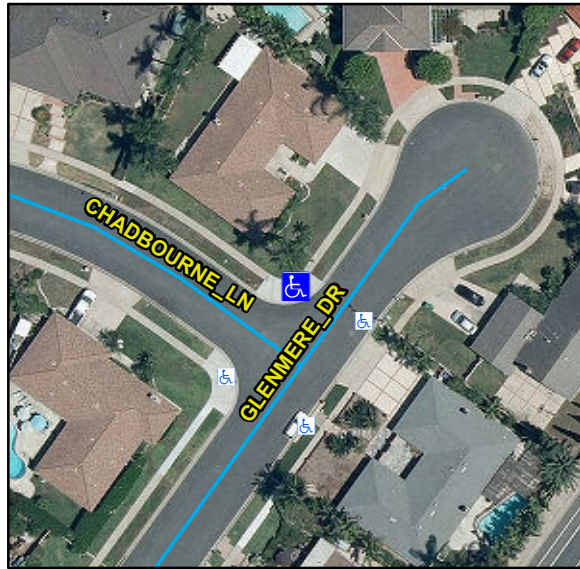
| Compliance | Description | Data | Compliance | Description | Data |
|---|---|---|---|---|---|
| No | Ramp Run Slope (%) | 12.3 | N/A | Flare Slope LT (%) | N/A |
| No | Ramp Cross Slope (%) | 5.2 | N/A | Flare Traversable LT | N/A |

Remove & Replace Curb Ramp With Two New Directional Ramps or Equivalent.

R304.2.2, R304.5.3, STD 1115
