# Access Compliance Report Public Rights-of-Way (Curb Ramps)

Main Street: NEWPORT\_AVE Cross Street: ST\_REGIS\_PL Location: S

ADA ID: RPRK211008135133 Ramp Type: Type 1 - Perpendicular Diagonal Initial Pass/Fail: Fail Overall Compliance: No Severity Score: 4

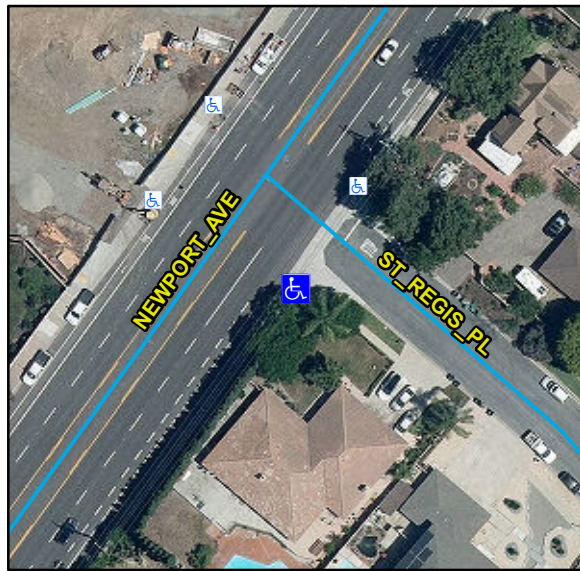
R304.2.2, R304.5.1, STD 1115

| Compliance | Description | Data | Compliance | Description | Data |
|---|---|---|---|---|---|
| No | Ramp Width (in) | 47 | | | N/A |

Remove & Replace Curb Ramp With Two New Directional Ramps or Equivalent.
