# Access Compliance Report Public Rights-of-Way (Curb Ramps)

Main Street: NEWPORT\_AVE Cross Street: RAVENCREST\_RD Location: E

ADA ID: RPRK211008140106 Ramp Type: Type 1 - Perpendicular Diagonal Initial Pass/Fail: Fail Overall Compliance: No Severity Score: 30

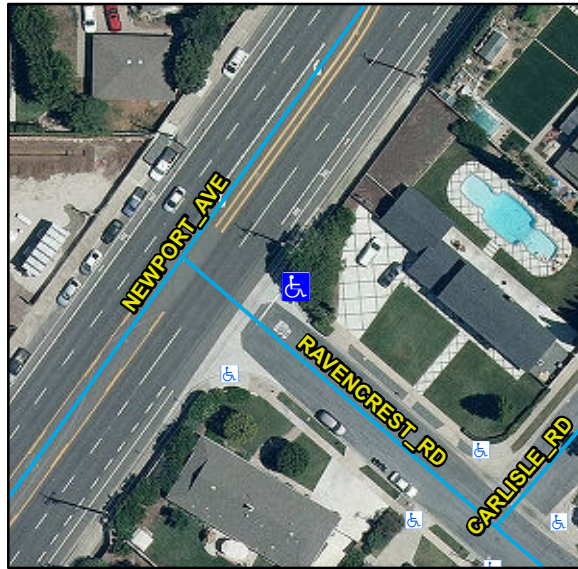
| Compliance | Description | Data | Compliance | Description | Data |
|---|---|---|---|---|---|
| No | Ramp Run Slope (%) | 12.1 | N/A | Flare Slope LT (%) | N/A |

Remove & Replace Curb Ramp With Two New Directional Ramps or Equivalent.

R304.2.2, STD 1115
