# Access Compliance Report Public Rights-of-Way (Curb Ramps)

Main Street: RAVENCREST\_RD Cross Street: CARLISLE\_RD Location: N

ADA ID: RPRK211008140423 Ramp Type: Type 1 - Perpendicular Diagonal Initial Pass/Fail: Fail Overall Compliance: No Severity Score: 45

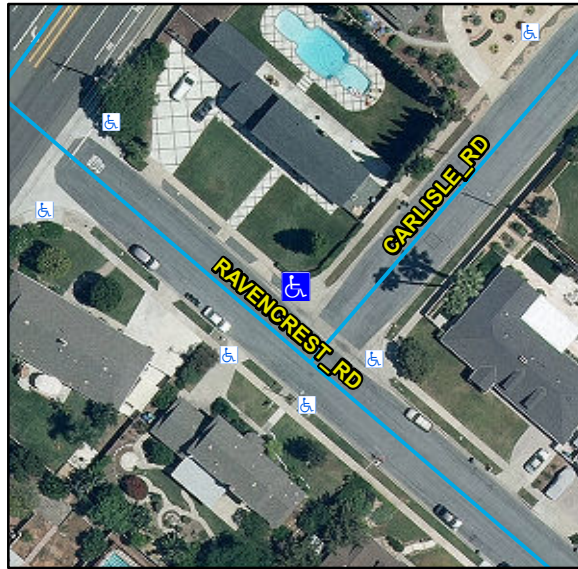
| Compliance | Description | Data | Compliance | Description | Data |
|---|---|---|---|---|---|
| No | Ramp Run Slope (%) | 13 | N/A | Flare Slope LT (%) | N/A |
| No | Ramp Cross Slope (%) | 6.3 | N/A | Flare Traversable LT | N/A |

Remove & Replace Curb Ramp With Two New Directional Ramps or Equivalent. Replace Spandrel.
