# Access Compliance Report Public Rights-of-Way (Curb Ramps)

Main Street: CARLISLE\_RD Cross Street: RAVENCREST\_RD Location: E

ADA ID: RPRK211008140603 Ramp Type: Type 1 - Perpendicular Diagonal Initial Pass/Fail: Fail Overall Compliance: No Severity Score: 30

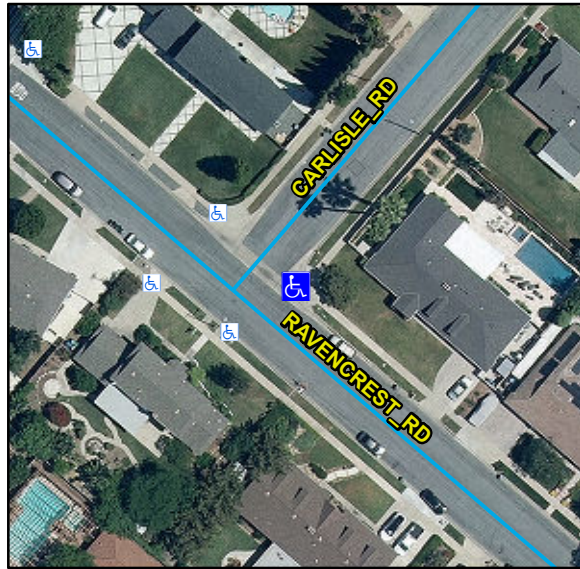
| Compliance | Description | Data | Compliance | Description | Data |
|---|---|---|---|---|---|
| No | Ramp Run Slope (%) | 12.6 | N/A | Flare Slope LT (%) | N/A |

Remove & Replace Curb Ramp With Two New Directional Ramps or Equivalent.

R304.2.2, STD 1115
