# Access Compliance Report Public Rights-of-Way (Curb Ramps)

Main Street: LA\_LOMA\_DR Cross Street: NEWPORT\_AVE Location: S

ADA ID: RPRK211008141353 Ramp Type: Type 1 - Perpendicular Diagonal Initial Pass/Fail: Fail Overall Compliance: No Severity Score: 15

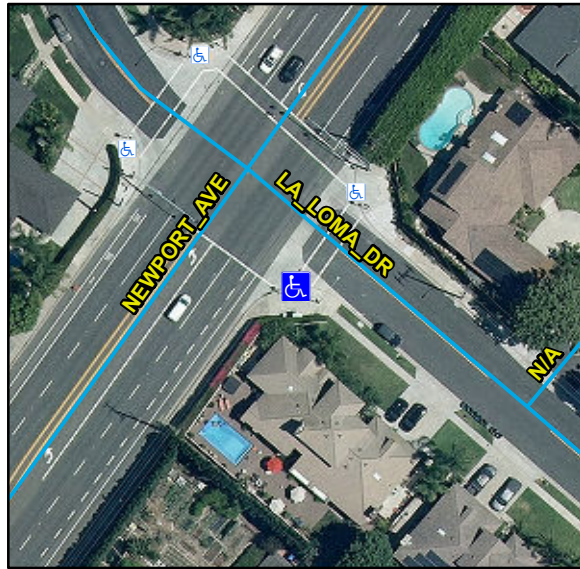
| Compliance | Description | Data | Compliance | Description | Data |
|---|---|---|---|---|---|
| No | Ramp Run Slope (%) | 11.3 | N/A | Flare Slope LT (%) | N/A |
| N/A | Gutter Ponding | N/A | No | Curb Slope | 13.2 |

Remove & Replace Curb Ramp With Two New Directional Ramps or Equivalent.

R304.2.2, R204.3, STD 1115
