# Access Compliance Report Public Rights-of-Way (Curb Ramps)

Main Street: LA\_LOMA\_DR Cross Street: NEWPORT\_AVE Location: N

ADA ID: RPRK211008142529 Ramp Type: Type 1 - Perpendicular Diagonal Initial Pass/Fail: Fail Overall Compliance: No Severity Score: 20

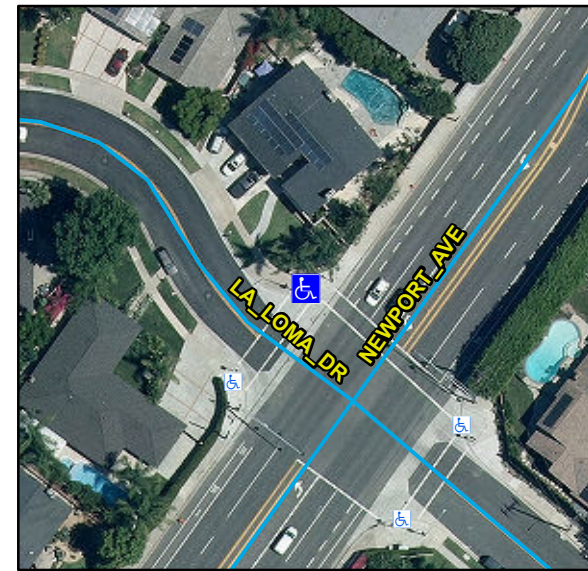
| Compliance | Description | Data | Compliance | Description | Data |
|---|---|---|---|---|---|
| No | Ramp Width (in) | 47 | | | N/A |
| No | Ramp Run Slope (%) | 11.4 | N/A | Flare Slope LT (%) | N/A |
| N/A | Gutter Ponding | N/A | No | Curb Slope | 17.6 |

Remove & Replace Curb Ramp With Two New Directional Ramps or Equivalent.
