# Access Compliance Report Public Rights-of-Way (Curb Ramps)

Main Street: NEWPORT\_AVE Cross Street: LA\_LOMA\_DR Location: W

ADA ID: RPRK211008143020 Ramp Type: Type 1 - Perpendicular Diagonal Initial Pass/Fail: Fail Overall Compliance: No Severity Score: 34

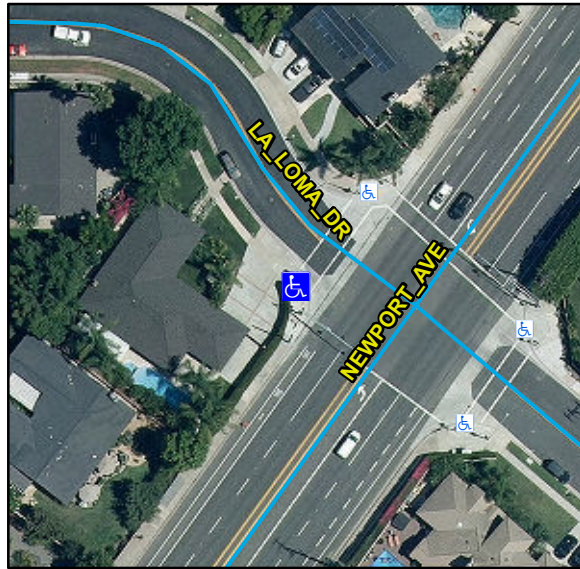
| Compliance | Description | Data | Compliance | Description | Data |
|---|---|---|---|---|---|
| No | Ramp Width (in) | 47 | | | N/A |
| No | Ramp Run Slope (%) | 11.5 | N/A | Flare Slope LT (%) | N/A |
| No | Ramp Cross Slope (%) | 7 | N/A | Flare Traversable LT | N/A |

**Remove & Replace Curb Ramp With Two New Directional Ramps or Equivalent.**

**R304.2.2, R304.5.1, R304.5.3, STD 1115**
