# Access Compliance Report Public Rights-of-Way (Curb Ramps)

Main Street: MARQUIS\_CIR Cross Street: CASTLEGATE\_LN Location: SE

ADA ID: RPRK211011110257 Ramp Type: Type 1 - Perpendicular Diagonal Initial Pass/Fail: Pass Overall Compliance: No Severity Score: 10

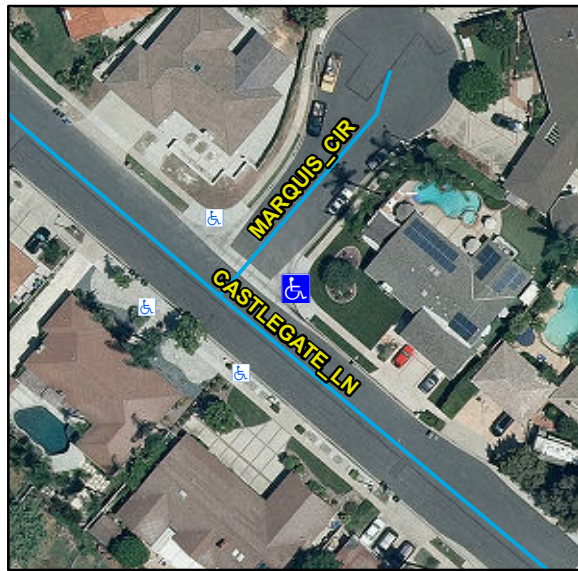
R304.2.2, R304.2.1, R304.2.2-Perp, R304.3.2-Para, R304.5.3, STD 1115

Remove & Replace Curb Ramp With Two New Directional Ramps or Equivalent.
