# Access Compliance Report Public Rights-of-Way (Curb Ramps)

Main Street: CASTLEGATE\_LN Cross Street: MARQUIS\_CIR Location: NE

ADA ID: RPRK211011110603 Ramp Type: Type 1 - Perpendicular Diagonal Initial Pass/Fail: Pass Overall Compliance: No Severity Score: 15

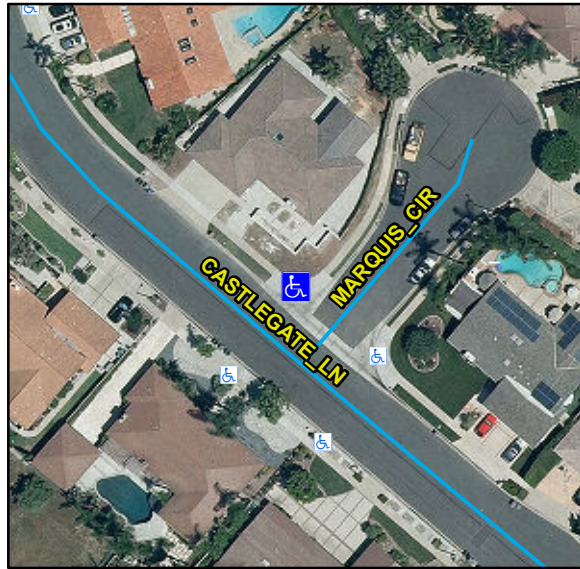
| Compliance | Description | Data | Compliance | Description | Data |
|---|---|---|---|---|---|
| No | Landing Width (in) | N/A | Yes | Flare Slope RT (%) | 9.9 |
| No | Landing Run Slope (%) | N/A | N/A | Flare Traversable RT | Yes |
| No | Landing Cross Slope (%) | N/A | Yes | DWS Provided | Yes |
| Yes | Gutter Ponding | No | No | Curb Slope | 13.8 |
| No | Gutter Run Slope (%) | 5.3 | | Road Cross Slope (%) | 8.1 |

Remove & Replace Curb Ramp With Two New Directional Ramps or Equivalent. Remove & Replace Gutter.
