# Access Compliance Report Public Rights-of-Way (Curb Ramps)

Main Street: CASTLEGATE\_LN Cross Street: CASTLEGATE\_LN Location: W

ADA ID: RPRK211011111011 Ramp Type: Type 1 - Perpendicular Diagonal Initial Pass/Fail: Fail Overall Compliance: No Severity Score: 16

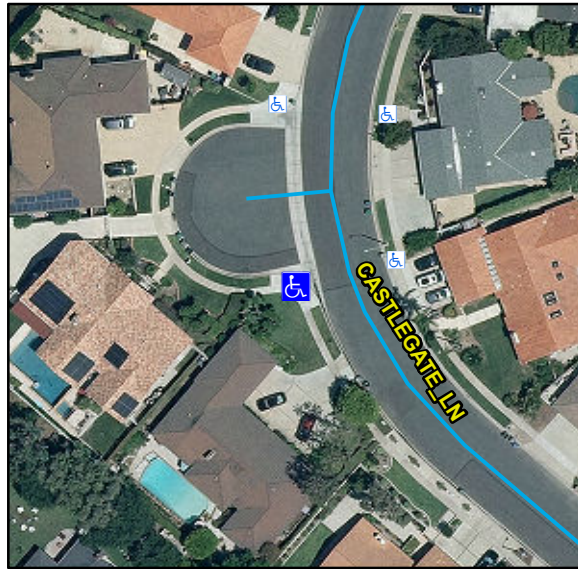
| Compliance | Description | Data | Compliance | Description | Data |
|---|---|---|---|---|---|
| No | Ramp Run Slope (%) | 11 | N/A | Flare Slope LT (%) | N/A |
| No | Ramp Cross Slope (%) | 2.3 | N/A | Flare Traversable LT | N/A |

Remove & Replace Curb Ramp With Two New Directional Ramps or Equivalent.

R304.2.2, R304.5.3, STD 1115
