# Access Compliance Report Public Rights-of-Way (Curb Ramps)

Main Street: CASTLEGATE\_LN Cross Street: CASTLEGATE\_LN Location: W

ADA ID: RPRK211011111230 Ramp Type: Type 1 - Perpendicular Diagonal Initial Pass/Fail: Fail Overall Compliance: No Severity Score: 32

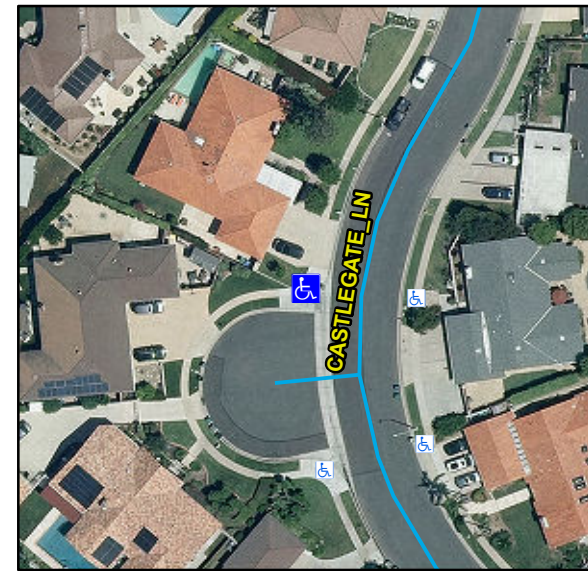
| Compliance | Description | Data | Compliance | Description | Data |
|---|---|---|---|---|---|
| No | Ramp Run Slope (%) | 15.2 | N/A | Flare Slope LT (%) | N/A |
| No | Ramp Cross Slope (%) | 2.6 | N/A | Flare Traversable LT | N/A |

**Remove & Replace Curb Ramp With Two New Directional Ramps or Equivalent.**

**R304.2.2, R304.5.3, STD 1115**
