Access Compliance Report Public Rights-of-Way (Curb Ramps)

Main Street: CASTLEGATE_LN **Cross Street:** CASTLEGATE_LN **Location:** E

ADA ID: RPRK211011111548 **Ramp Type:** Type 1 - Perpendicular Diagonal Initial Pass/Fail: Fail **Overall Compliance:** No **Severity Score:** 15

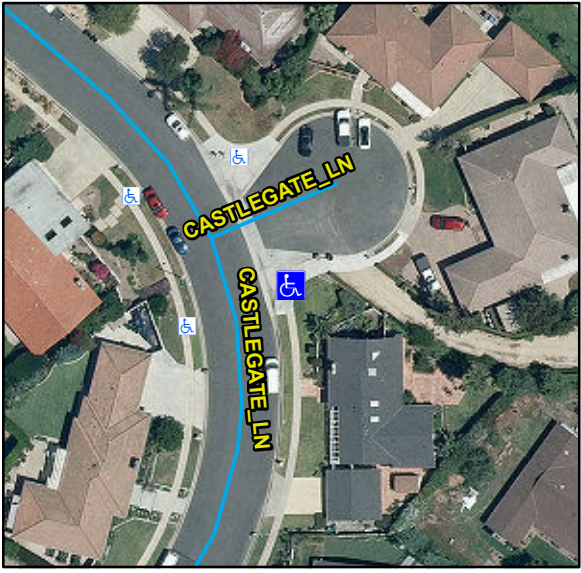
Compliance	Description	Data	Compliance	Description	Data
N/A	Ramp Length (in)	104	N/A	Flare Type LT	
Yes	Ramp Width (in)	48			N/A
No	Ramp Run Slope (%)	9.9	N/A	Flare Slope LT (%)	N/A
Yes	Ramp Cross Slope (%)	0.4	N/A	Flare Traversable LT	N/A
N/A	Landing Present	N/A	N/A	Flare Type RT	
N/A	Landing Length (in)	N/A			N/A
N/A	Landing Width (in)	N/A	N/A	Flare Slope RT (%)	N/A
N/A	Landing Run Slope (%)	N/A	N/A	Flare Traversable RT	N/A
N/A	Landing Cross Slope (%)	N/A	N/A	DWS Provided	N/A
N/A	Landing Movement Obstructed?	N/A	N/A	DWS Contrast	N/A
	Landing Movement Type	N/A	N/A	DWS Length (in)	N/A
N/A	Landing Shared	N/A	N/A	DWS Full Width	N/A
N/A	Clear Space	Yes	N/A	DWS Offset Left (in)	N/A
N/A	Clear Space To Crosswalk (in)	N/A	N/A	DWS Offset Right (in)	N/A
N/A	Marked Crosswalk 1	No	N/A	Marked Crosswalk 2	No
	Crossing 1 Direction	N		Crossing 2 Direction	W
	Marked Crosswalk 1 Width (in)	N/A		Marked Crosswalk 2 Width (in)	N/A

N/A	Ramp Inside Crosswalk 1	N/A	Yes	Ramp Inside Crosswalk 2	N/A
	Crossing 1 Slope (%)	11.5		Crossing 2 Slope (%)	3.7
	Crossing 1 Cross Slope (%)	2.6		Crossing 2 Cross Slope (%)	2
N/A	Gutter Ponding	N/A	No	Curb Slope	22.1
Yes	Gutter Lip Height (in)	0		Road Run Slope (%)	2.7
N/A	Gutter Run Slope (%)	N/A		Road Cross Slope (%)	1.1
N/A	Gutter Cross Slope (%)	N/A			
Yes	Overall Surface Condition: Acceptable		Yes	Perp Joint Present	Yes
	Cross Gutter Present?	Yes		Spandrel Present?	Yes
	Replace Cross Gutter?	No		Replace Spandrel?	No

Possible Solutions:
Remove & Replace Curb Ramp With Two New Directional Ramps or Equivalent.

OC Std/PROW:
 R304.2.2, STD 1115

Total Cost: \$ **6160**
