# Access Compliance Report Public Rights-of-Way (Curb Ramps)

Main Street: CASTLEGATE\_LN Cross Street: CASTLEGATE\_LN Location: E

ADA ID: RPRK211011111723 Ramp Type: Type 1 - Perpendicular Diagonal Initial Pass/Fail: Fail Overall Compliance: No Severity Score: 32

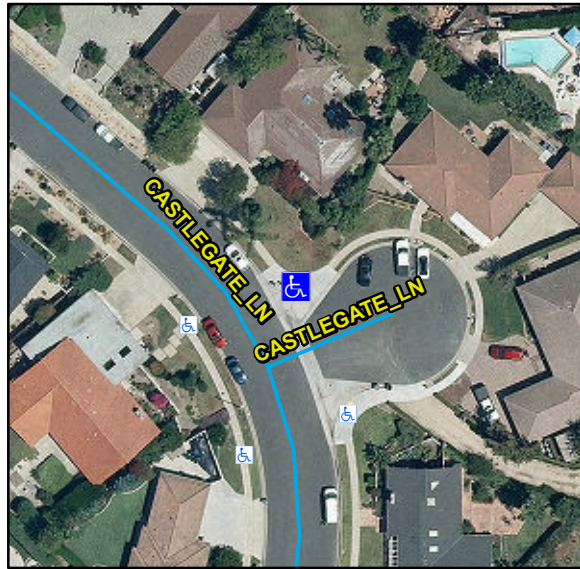
| Compliance | Description | Data | Compliance | Description | Data |
|---|---|---|---|---|---|
| No | Ramp Run Slope (%) | 12.6 | N/A | Flare Slope LT (%) | N/A |
| No | Ramp Cross Slope (%) | 2.3 | N/A | Flare Traversable LT | N/A |

**Remove & Replace Curb Ramp With Two New Directional Ramps or Equivalent.**
