# Access Compliance Report Public Rights-of-Way (Curb Ramps)

Main Street: THEODORA\_DR Cross Street: PROSPECT\_AVE Location: SE

ADA ID: RPRK211011115627 Ramp Type: Type 7 - Directional 2 Initial Pass/Fail: Fail Overall Compliance: No Severity Score: 30

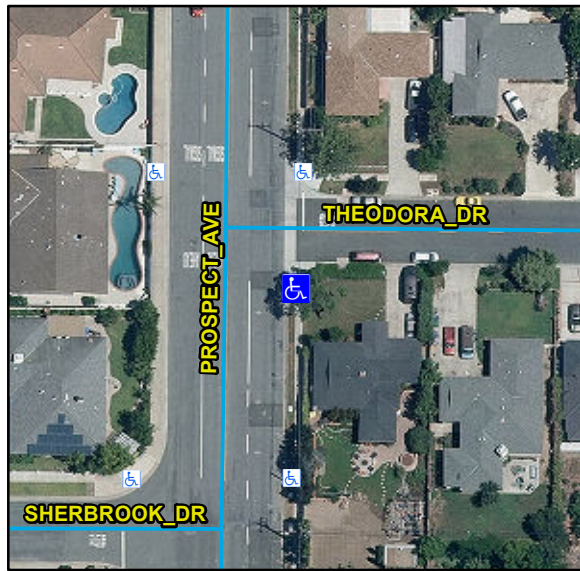
| Compliance | Description | Data | Compliance | Description | Data |
|---|---|---|---|---|---|
| No | Obstructions Present? | Yes | N/A | Utilities Present? | No |
| | Obstruction Types | Vegetation | | Utility Types | |

| Compliance | Description | Data | Compliance | Description | Data |
|---|---|---|---|---|---|
| No | Ramp Cross Slope (%) | 12.7 | N/A | Flare Traversable LT | N/A |

Remove & Replace Entire Ramp.

R304.5.3, R302.3, R402.2, STD 1115
